Report No. RT/ELE/12171
Date: 02/09/2013
Order No. UK016-2189
Quote No. N/A
Sample Received 20/08/2013

RoHS Risk Assessment

A Fragrance Dispenser was received from Washroom Wizard, the equipment was dismantled and 45 homogenous materials were XRF pre-screened for RoHS compliance. The Printed Circuit Boards were Risk Assessed by XRF mapping.

Lab Sample No: ELE-244522
Sample Description: Ecobreeze air filtration and air fragrance diffuser

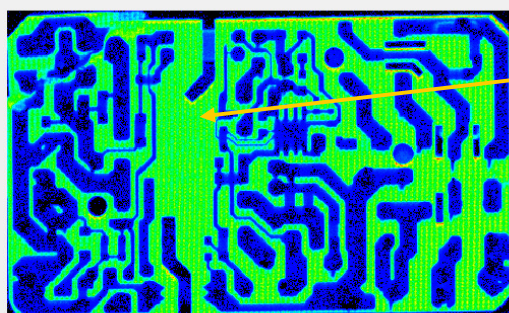
Bromine Map

Bromine in board low risk

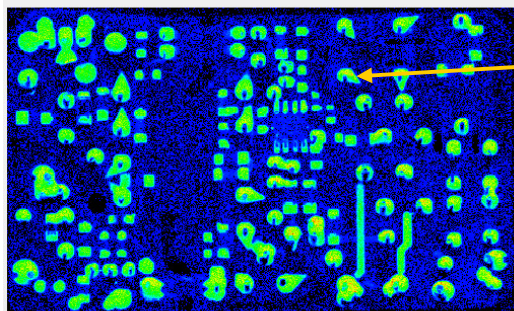
Tin Map

Tin used in solder and component legs, not lead

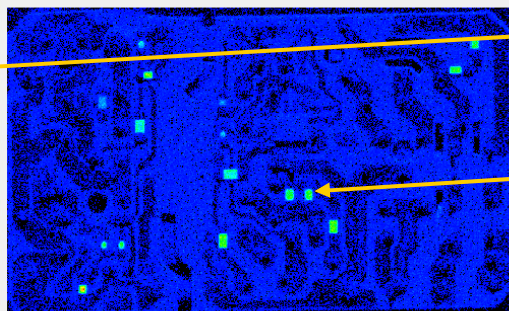
Lead Map

Lead detected in resistors requires checking for exemptions

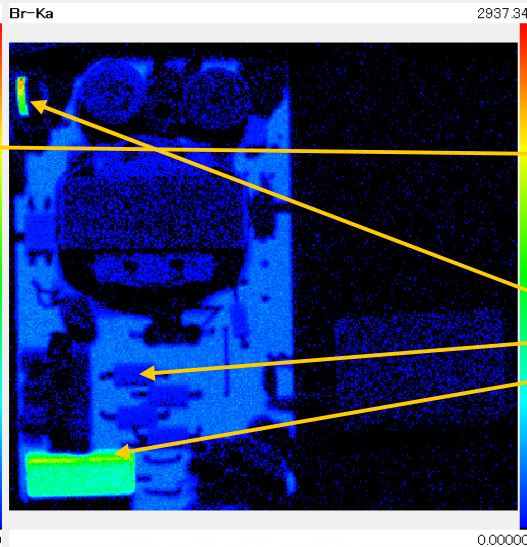
Bromine Map

Bromine in board low risk

Bromine detected in:

- White plastic washer
- Resistors
- Yellow capacitor

Require PBB/PBDE speciation by GC-MS Analysis and/or supplier evaluation.

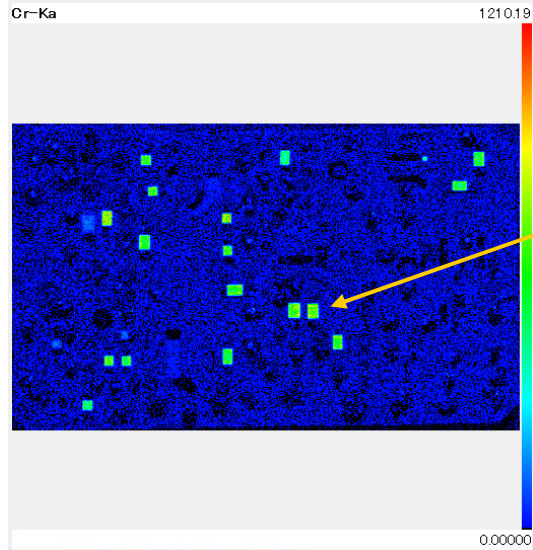
Chromium Map

Chromium detected in resistors requires Cr VI speciation by supplier evaluation.

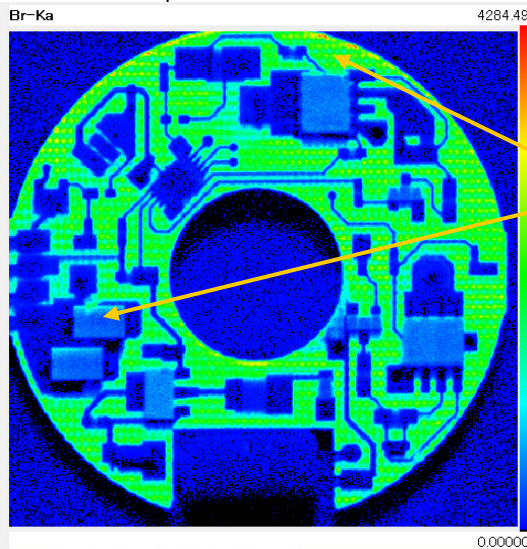
Bromine Map

Bromine in board low risk.
Bromine detected in IC also low risk

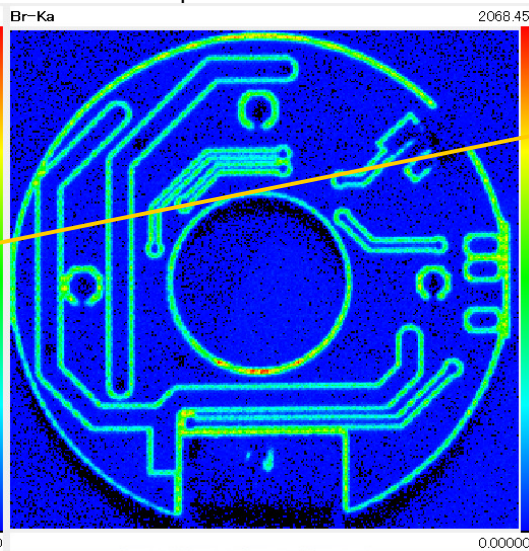
Bromine Map

Bromine in board low risk

There was no lead solder detected in this side of the board above.

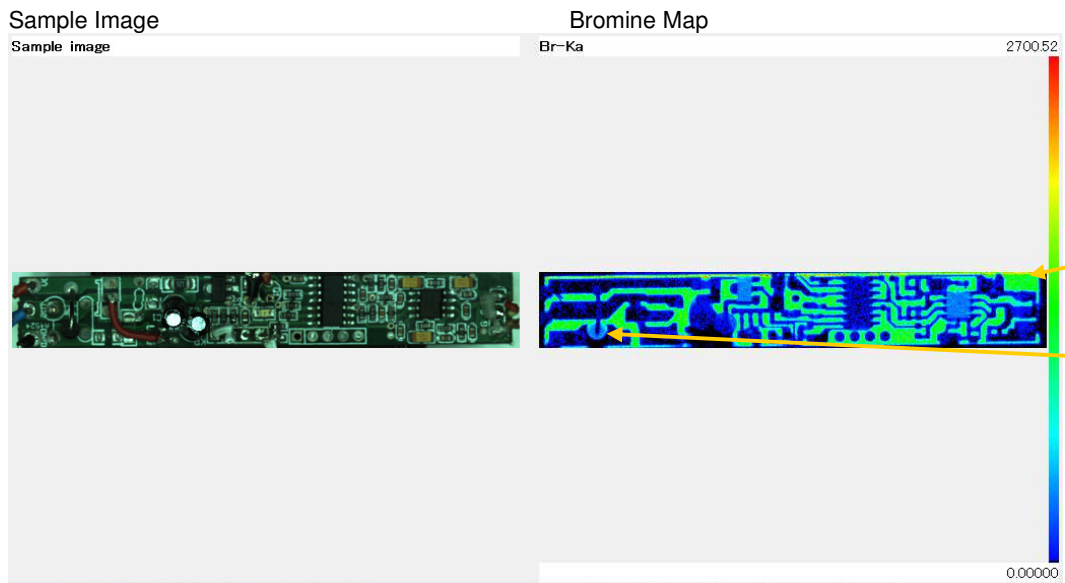
Bromine in board low risk.
Bromine detected in the black resistor requires PBB/PBDE speciation by GC-MS Analysis and/or supplier evaluation.

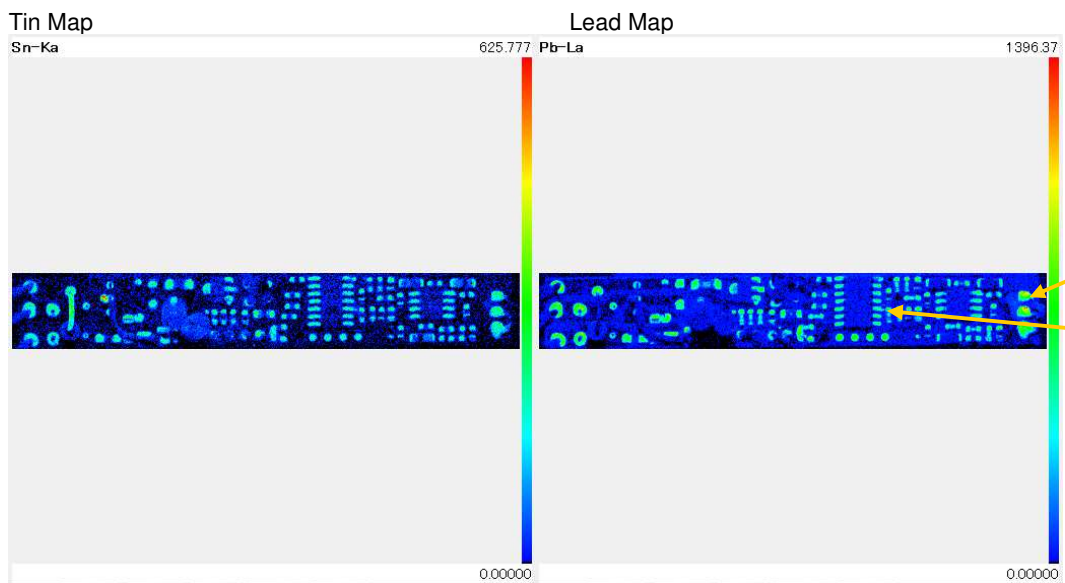
Lead used in solder and component legs throughout PCBs.

Leaded solder was detected in the third PCB (as indicated in the mapping). Lead was also detected in 2 solder spots and 3 cable insulations from the XRF pre-screening.

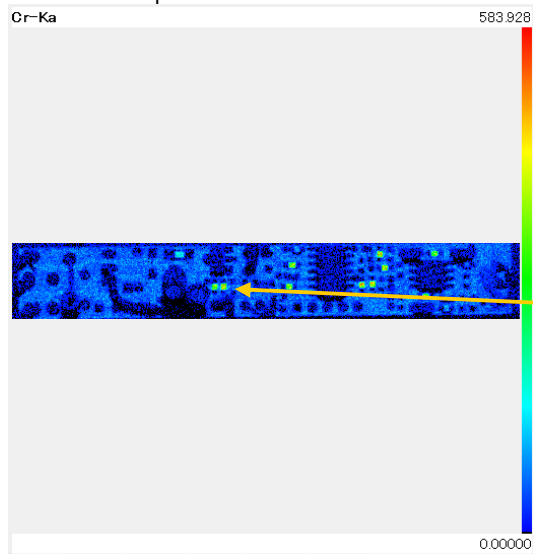
Chromium Map

Chromium detected in resistors requires Cr VI speciation by supplier evaluation.

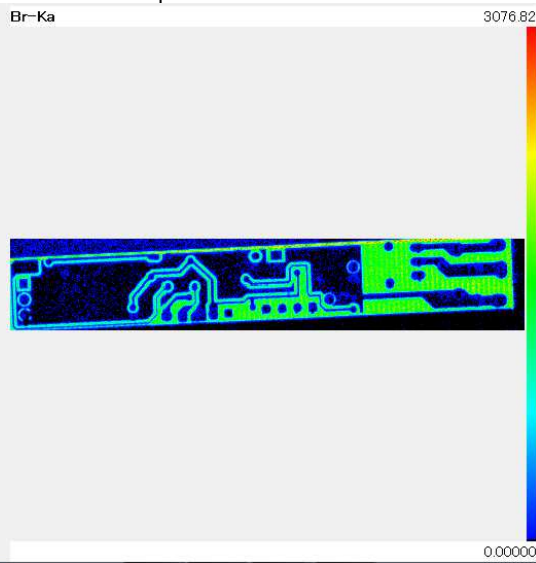
Bromine Map

Bromine in board low risk
