Report No. RT/ELE/12171
Date: 02/09/2013
Order No. UK016-2189
Quote No. N/A
Sample Received 20/08/2013

RoHS Risk Assessment

A Fragrance Dispenser was received from Washroom Wizard, the equipment was dismantled and 45 homogenous materials were XRF pre-screened for RoHS compliance. The Printed Circuit Boards were Risk Assessed by XRF mapping.

Lab Sample No: ELE-244522
Sample Description: Ecobreeze air filtration and air fragrance diffuser

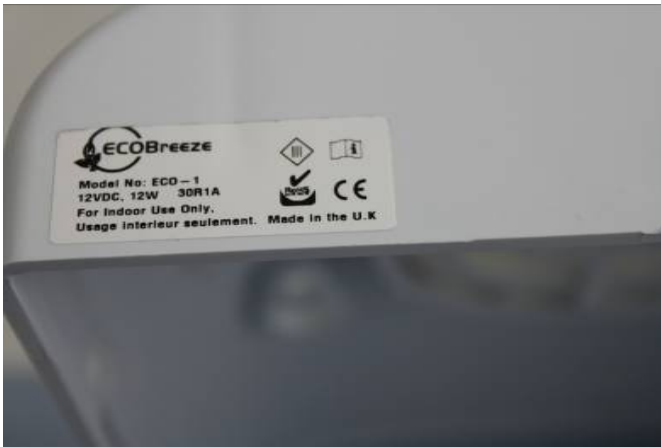
244522a – White front plastic cover

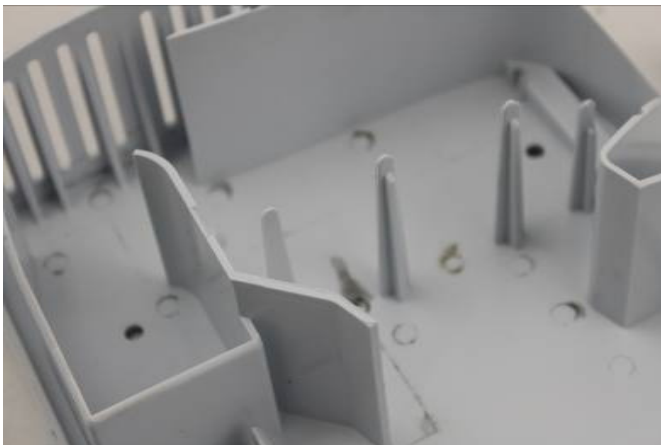
244522b – White rear plastic cover

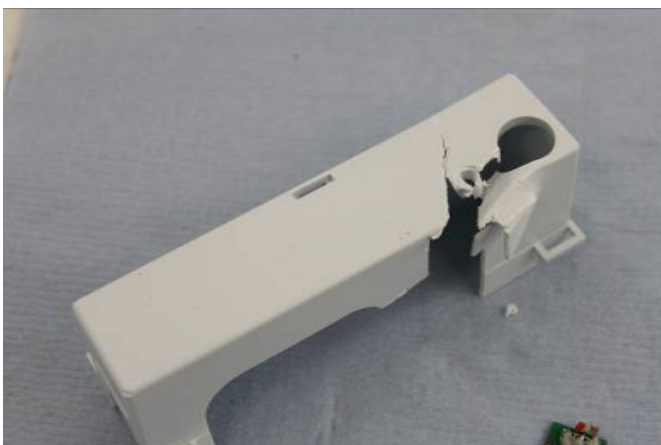
244522c – Electronics white plastic casing

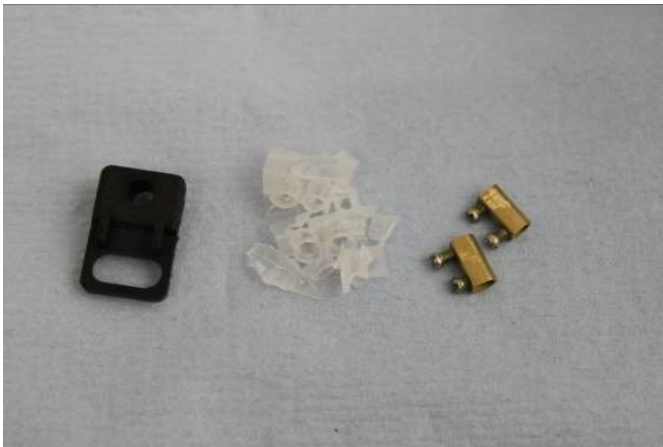
- 244522d1 – Black spacer
- 244522d2 – Clear contact box casing
- 244522d3 – Metal contacts

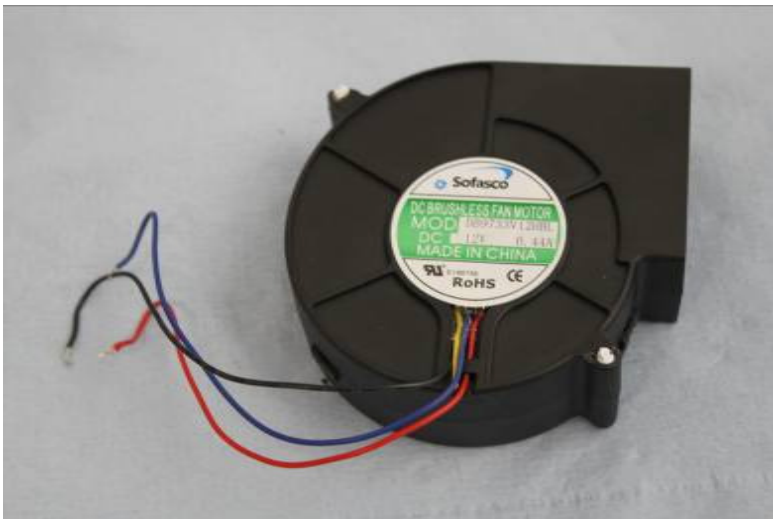
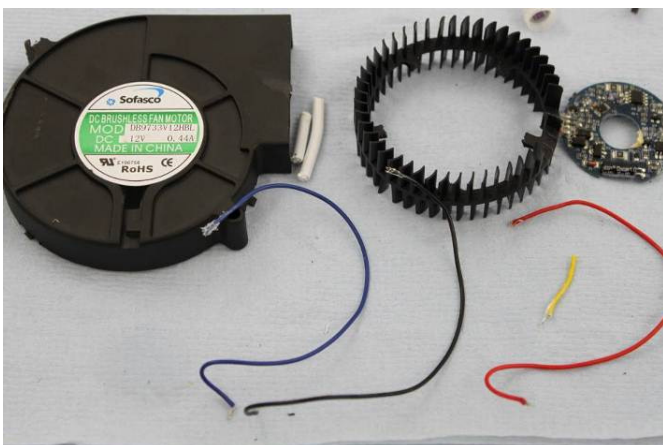
- 244522e1 – Fan main black casing
- 244522e2 – White supports
- 244522e3 – Fan inner black plastic
- 244522e4 – PCB see Mapping
- 244522e5 – Blue cable insulation
- 244522e6 – Black cable insulation
- 244522e7 – Yellow cable insulation
- 244522e8 – Red cable insulation

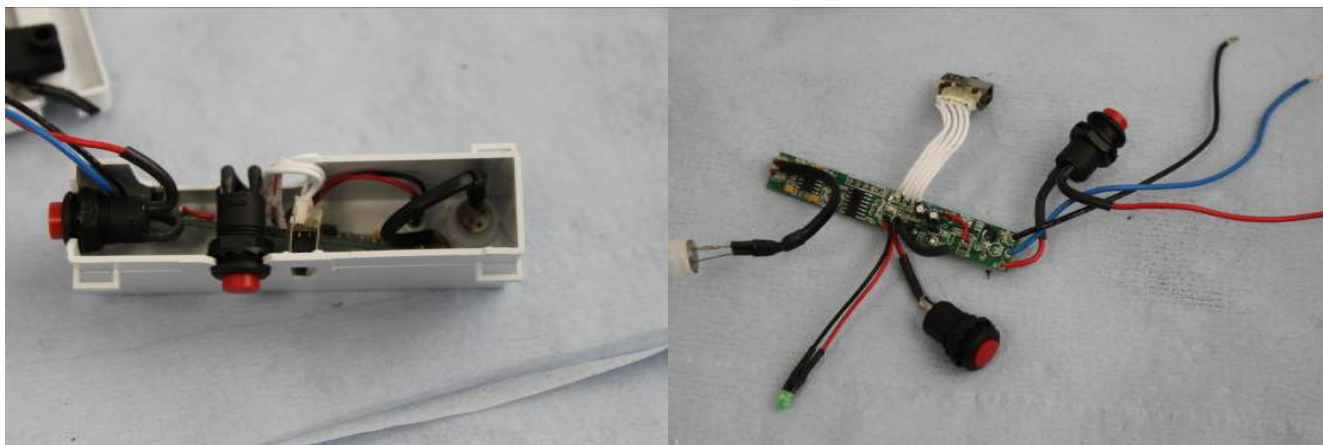
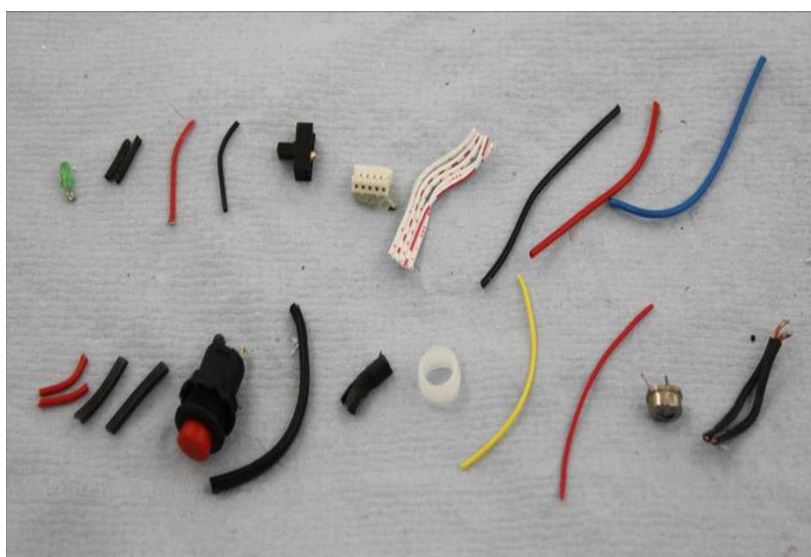
- 244522f1 – PCB see below
- 244522f2 – Green LED
- 244522f3 – Green LED solder
- 244522f4 – Black cable sheath
- 244522f5 – Red cable insulation
- 244522f6 – Black cable insulation
- 244522f7 – Black switch
- 244522f8 – White contact block
- 244522f9 – White/pink ribbon
- 244522f10 – Black cable insulation
- 244522f11 – Red cable insulation
- 244522f12 – Blue cable insulation
- 244522f13 – Red cable insulation
- 244522f14 – Black cable sheath
- 244522f15 – Red button
- 244522f16 – Black switch casing
- 244522f17 – Solder on switch
- 244522f18 – Black cable insulation
- 244522f19 – Black cable sheath
- 244522f20 – White o-ring around device
- 244522f21 – Yellow cable insulation
- 244522f22 – Red cable insulation
- 244522f23 – Solder inside device
- 244522f24 – Solder to power supply

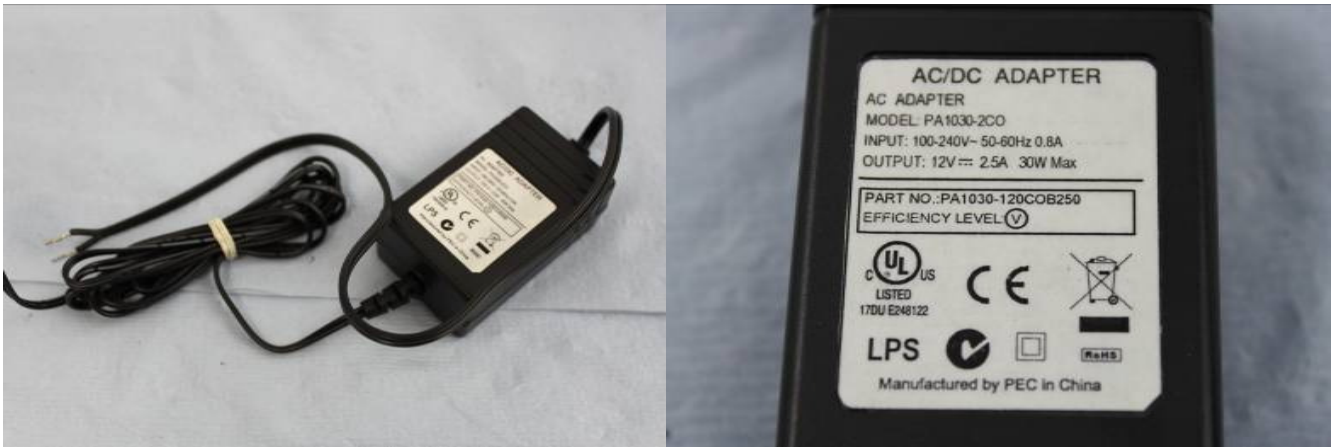
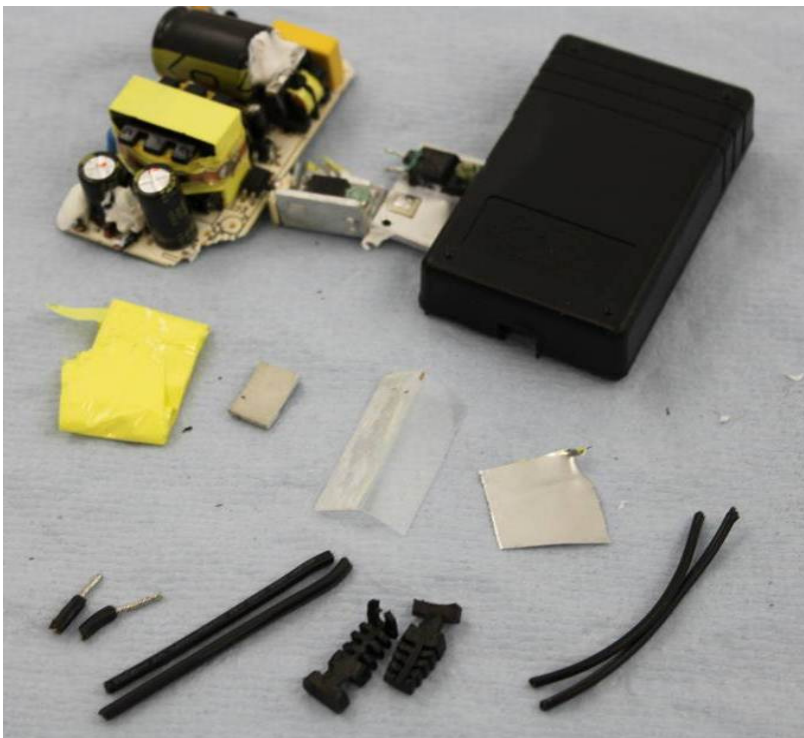
- 244522g1 – PCB see Mapping
- 244522g2 – Black casing
- 244522g3 – Yellow tape
- 244522g4 – Grey sticky spacer
- 244522g5 – Clear Perspex
- 244522g6 – Metal casing
- 244522g7 – Solder on wires
- 244522g8 – Black cable insulation (large)
- 244522g9 – Black plastic cable ends
- 244522g10 – Black cable insulation (small)

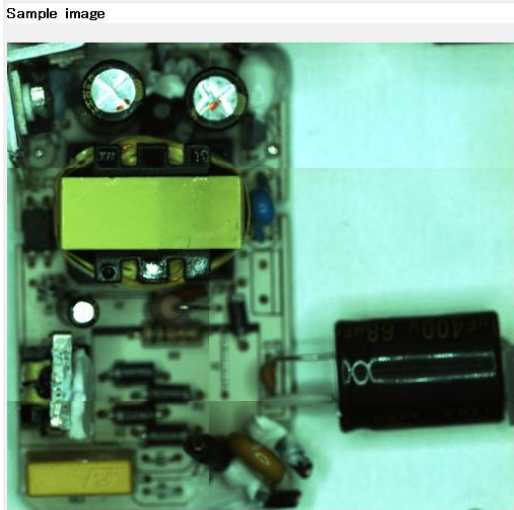
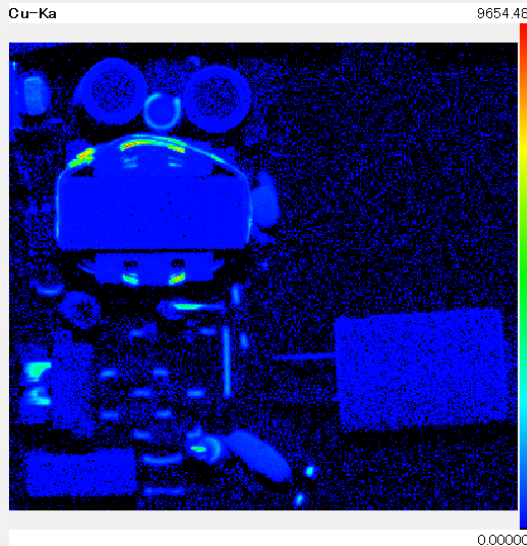
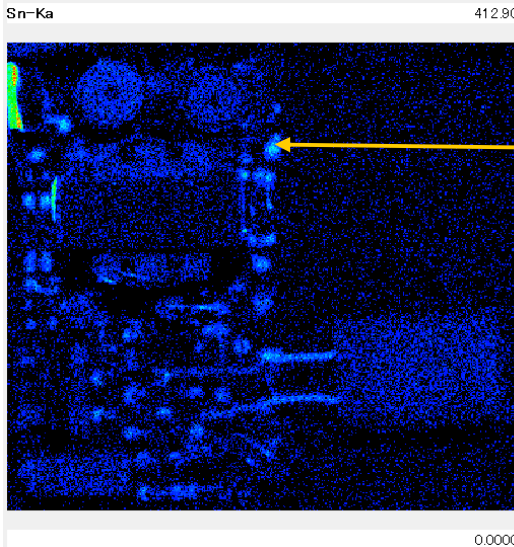
Tin used in solder and component legs, not lead

Bromine in board low risk

Bromine detected in:

- White plastic washer
- Resistors
- Yellow capacitor

Require PBB/PBDE speciation by GC-MS Analysis and/or supplier evaluation.

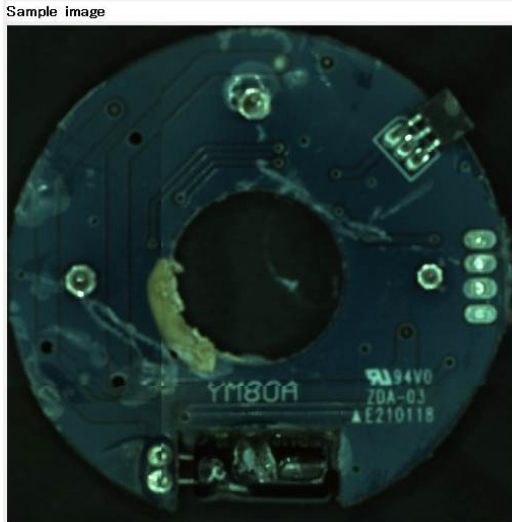
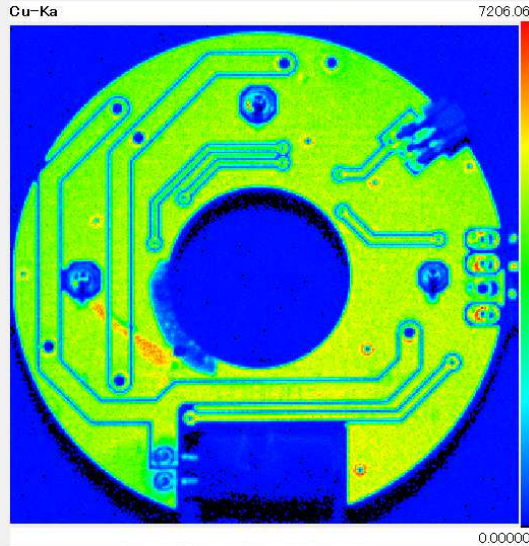
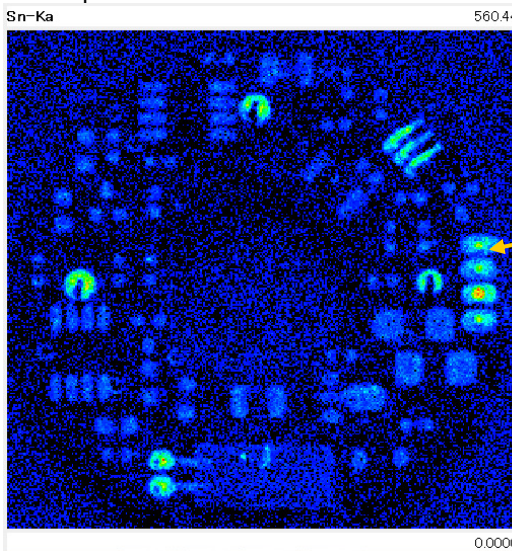
Tin used in solder and component legs, not lead

Bromine in board low risk

There was no lead solder detected in this side of the board above.
